Inspection Report **Muayene Raporu**

No. 19-IS-0286b-34-B-001 Rev. 00

HIGH-PRESSURE JETTING RESISTANCE TEST ACCORDING TO DIN 19523 - PRACTICAL TEST

DN 300 PN 1 SN 10000 Glassfiber Reinforced Polyester Pipe

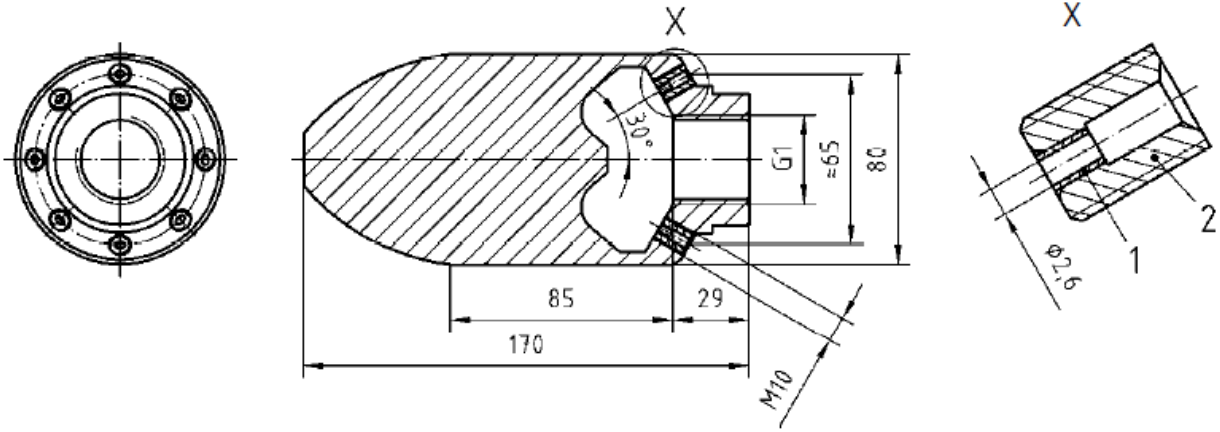
Fig.1 standard nozzle for the practical test

Parameter	Value
Length of nozzle	(17 ± 0,5) cm
Weight of nozzle	(4,5 ± 0,1) kg
Diameter of nozzle	(8 ± 0,5) cm

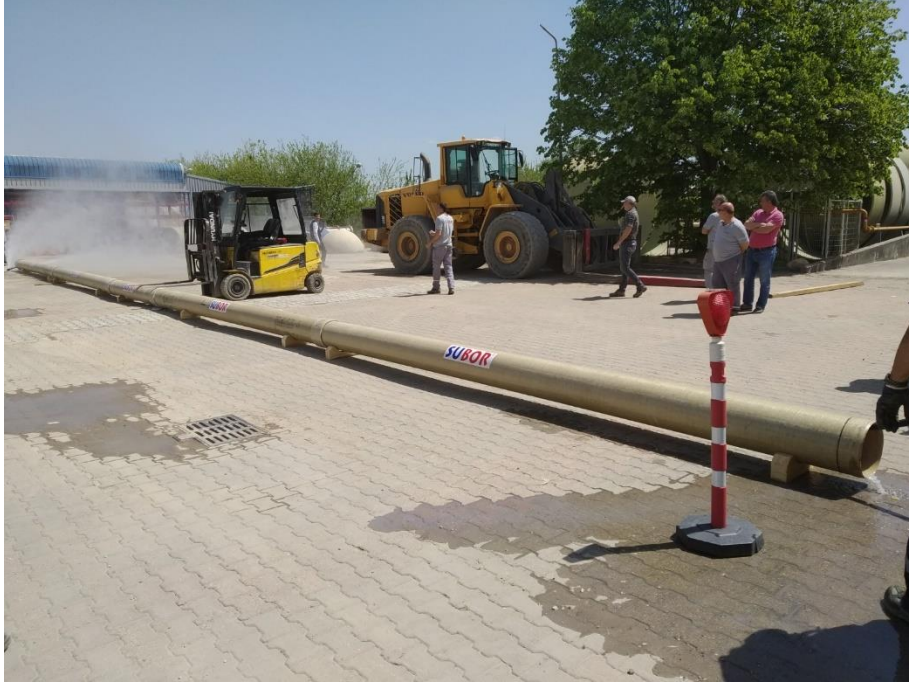
Photo 1 – test-route while testing

The test-route consisted of whole pipes and fittings. It was placed straight and in a stable position and had a length of 18 meters (see photo 1).

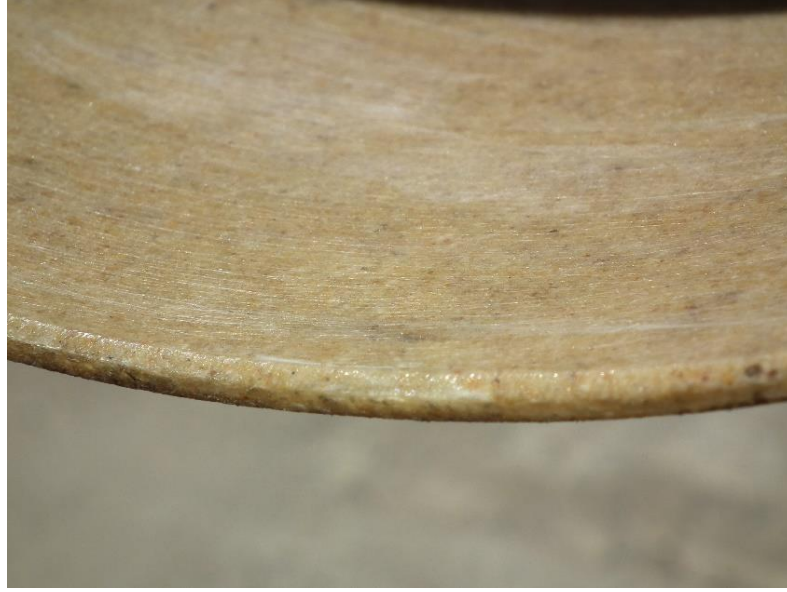
Photo 2 – pipe bottom after test

Activity No Aktivite No	Results and comments related to inspections Muayene sonuçları ve görüşler	Note Not
	- After testing the pipes were visually inspected and no damages were detected.
