TEST SUMMARY

Product: VIP 110mm Lateral Connector

Test: Maintain 0.5 bar for a period of 15 mins without leakage

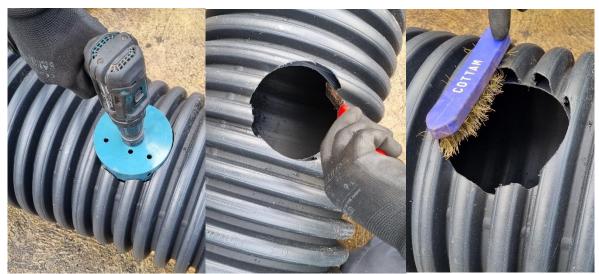
Hole drilled in 300mm corrugated pipe using 127mm Hole saw drill. This resulted in swarf remnants which were removed using a wire brush and a knife blade. It was important to ensure the hole was drilled in a straight vertical plane as if drilled out of true, the corrugations would prevent the seal from engaging. A continuous drill speed will help prevent the hole saw from snaging.

The 110mm lateral connector seal passed the 0.5bar 15 minute tests, in accordance with EN295 water tightness without any visible drop in pressure or leakage. The outcome of the tests are very much dependent upon correct installation, in particular ensuring the hole is drilled at a straight 90 degree angle, fully de-burred and also that the 110mm outlet pipe is fully inserted (by 85mm) into the seal.

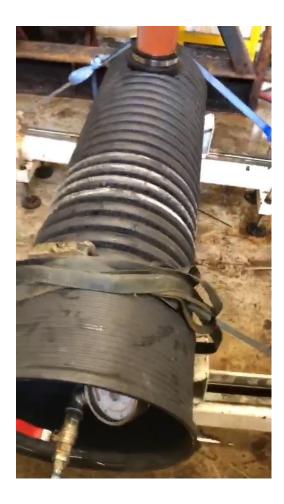
At 12:35 on 9th June 2022, the unit was pressurised to 0.5 bar and this was maintained until 12:50 with no visible leaks or drop in recorded pressure.

DN300 Twin-wall pipe x 110mm lateral twin-wall adaptor.

Result: No visible leaks after 15 minutes and no pressure drop on the guage.

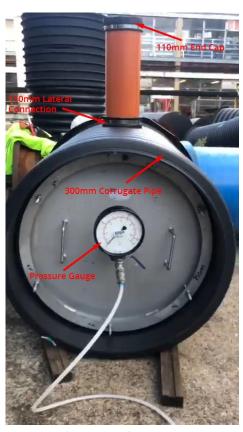
DN750 Twin-wall pipe x 110mm twin-wall lateral adaptor at 0.5bar.

At 13:30 on 9th June 2022, the unit was pressurised to 0.5 bar and this was maintained until 13:30 with no visible leaks or drop in recorded pressure. Pressure test was increased up to 2 bar for a further 15 minutes, with no signs of leakage.

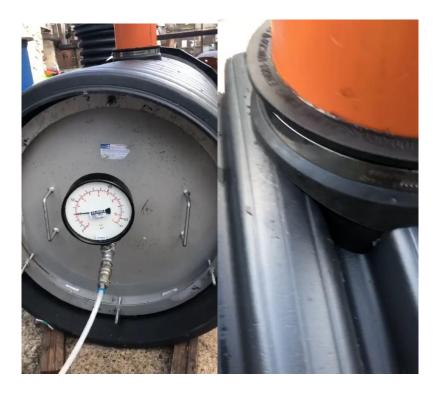
DN750 Twin-wall pipe x 110mm twin-wall lateral adaptor at 2bar

Result: No visible leaks after 15 minutes and no pressure drop on the guage.
