<b>nyrup plast</b>	Projection:	Sheet	1 of 1	Scale	1:20	Format	A3
	Weight kg.	Creator	CB	Date	01-06-2022		
Description	Klimabrønd Regnvand 600/110 - MAX 6LS			Drawing name	SE-00806		
Owner	Nyrup Plast			Model name	SE-00806		
Production standard	NPC			Project number:	038-016	Revision	A

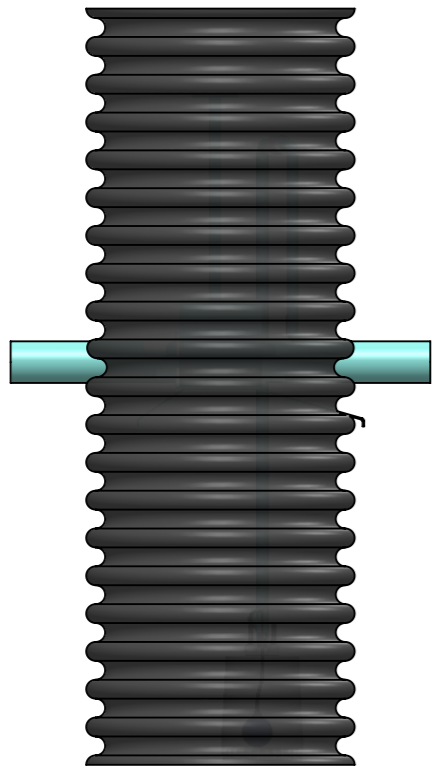
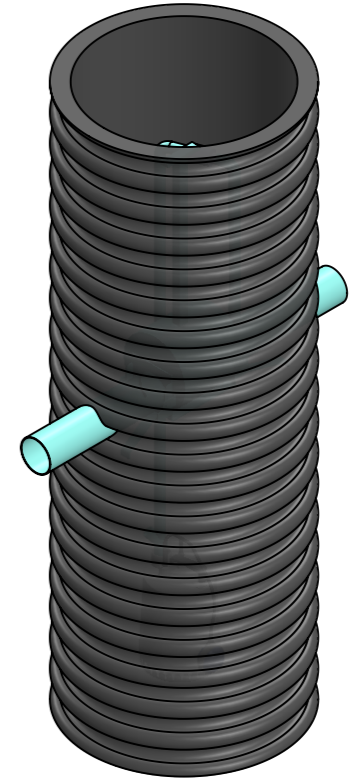
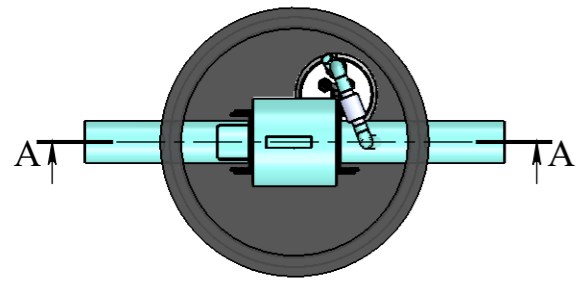
8	SE-00820	Non-Return valve	A	1	1.4301_AISI 304
7	SE-00818	Hose	A	1	1.4301_AISI 304
6	SE-00817	Quickkobling	A	1	.
5	SE-00816	Hose	A	1	1.4301_AISI 304
4	SE-00813	Pump AP12	A	1	
3	SE-00812	Gate	A	1	1.4301_AISI 304
2	SE-00805	Stainless Water gate	A	1	1.4301_AISI 304
1	SE-00804	ø600 Well	A	1	PP
Pos.	Part no.	Description	revision	QTY	Material
